Seismic Vulnerability Assessment

Kodiak Island Borough

G&E Engineering Systems Inc.

*G&E Report 87.01.05, Revision 0
February 12, 2006*

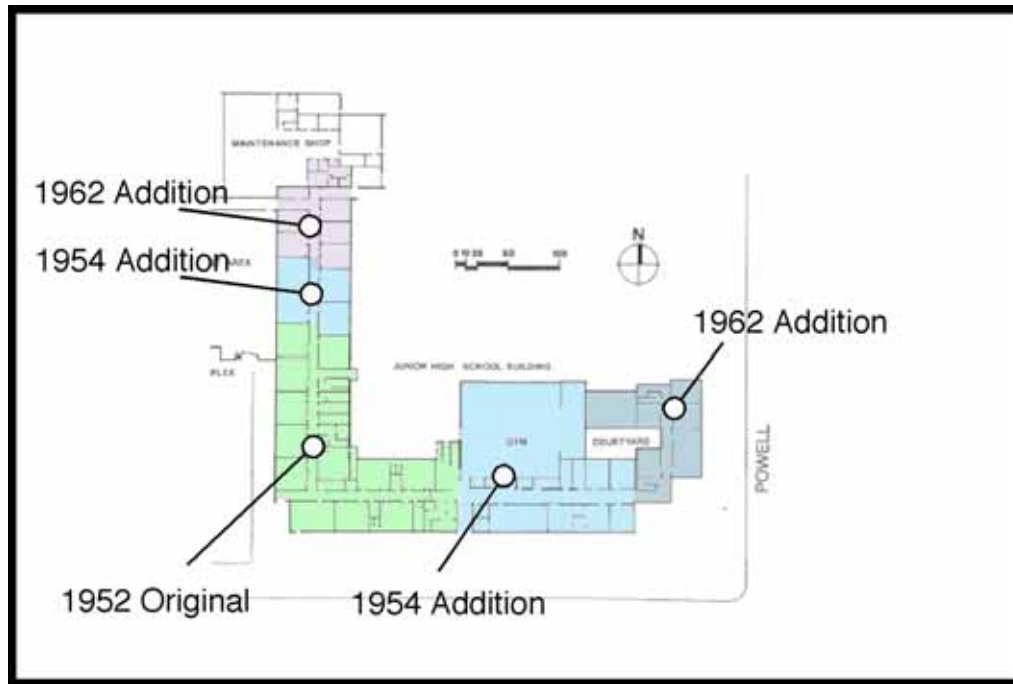
Figure 2-1. Middle School

The Kodiak Middle School (KMS) was built in several stages. The original portion (now the southwest corner) of the building was built in 1952. Substantial additions were made in 1954, 1959¹⁰ and 1962. A minor addition and a renovation was made in 1983. Figures 2-1, 2-2 and 2-3 outline the various additions and floor plans of the building.

The building as it is built today consists of various types of structural systems. The original 1952 and 1954 single story construction uses a combination of non-ductile reinforced concrete columns, discontinuous reinforced concrete walls and timber. The subsequent construction uses a combination of reinforced concrete walls and non-ductile columns, steel columns, steel beams, steel joists, concrete floor slab with steel panel, and steel panel roof.

Most of the classroom areas in the 1952 and 1954 construction incorporate a "monitor" level above the main classroom areas. This monitor level provides attic space and second story level windows. It is built using heavy glulam, post and beam wood construction, using a 3x6 straight sheathing for the roof system. The break in the roof diaphragm

caused by the monitor level substantially weakens the seismic load-carrying capacity of these portions of the building. Figures 2-6 and 2-7 highlight the weaknesses.

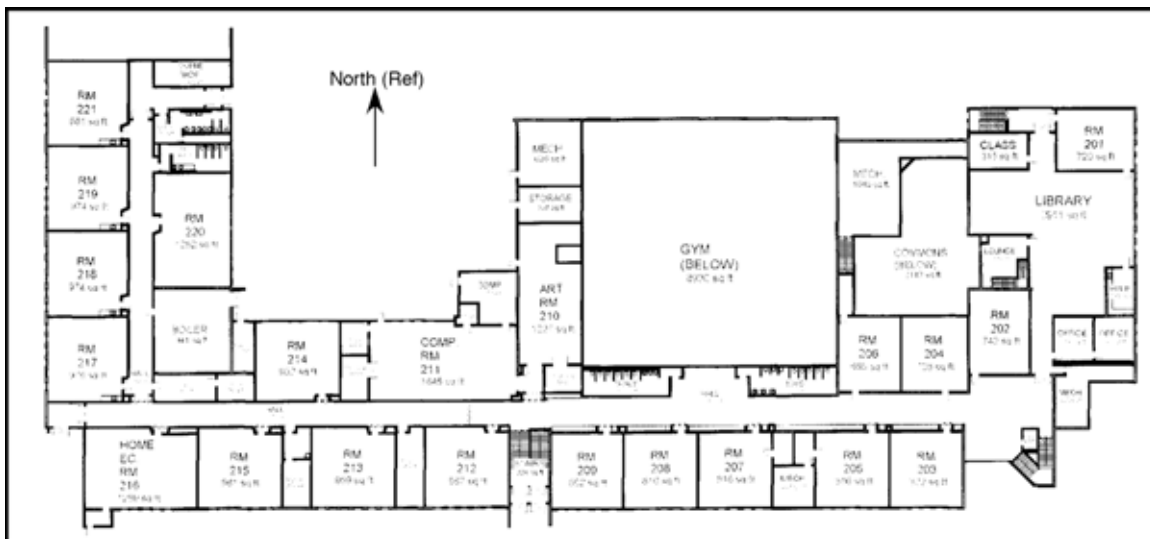
Figure 2-3. Plan of Upper Level – Gym and East Additions; and Original 1952 Building

Most of the current east, south and west facades, as well as limited portions of the other facades, use a combination of reinforced concrete footing wall, short reinforced concrete columns through a window level, and then a reinforced concrete wall up to the roof level. The reinforced concrete columns (Figure 2-5) use #2 bars as ties at 12-inch spacing.

While this type of column detail was commonly used prior to 1970, experience in past earthquakes now shows that this type of column is non-ductile, and the short column effect caused by the window configuration further aggravates the ductility demand on the columns under sufficiently large earthquakes.

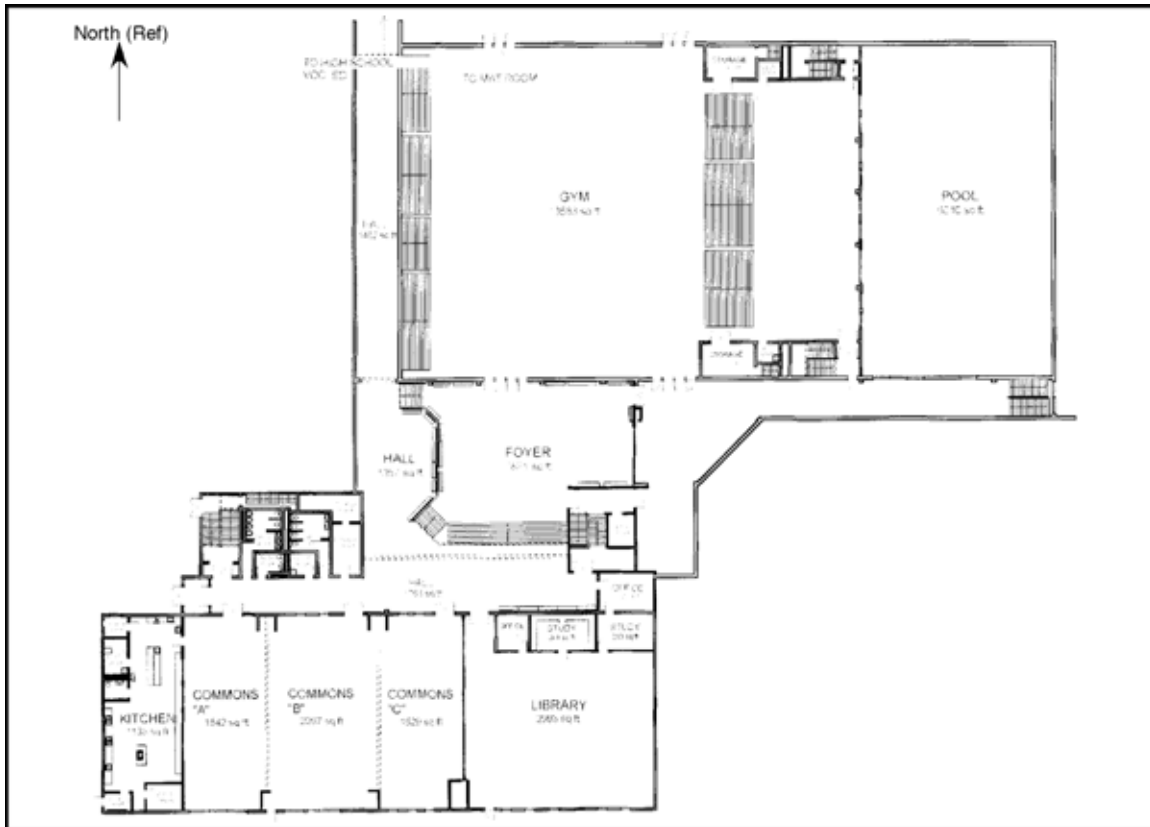
Figure 2-9a. Plan of Gym, Pool and Library

The Gym, Pool Commons and Library wing were designed in 1972. Design loads were: UBC Zone 3 (1970 edition). The concrete masonry units (CMUs) were filled where reinforced and left void where not reinforced; the steel decks were designed to act as diaphragms.

The library section is steel column with CMU infill walls. Figure 2-9a shows the plan of the lower floor (including the gym and pool) and Figure 2-9b shows a larger scale plan of the second floor.

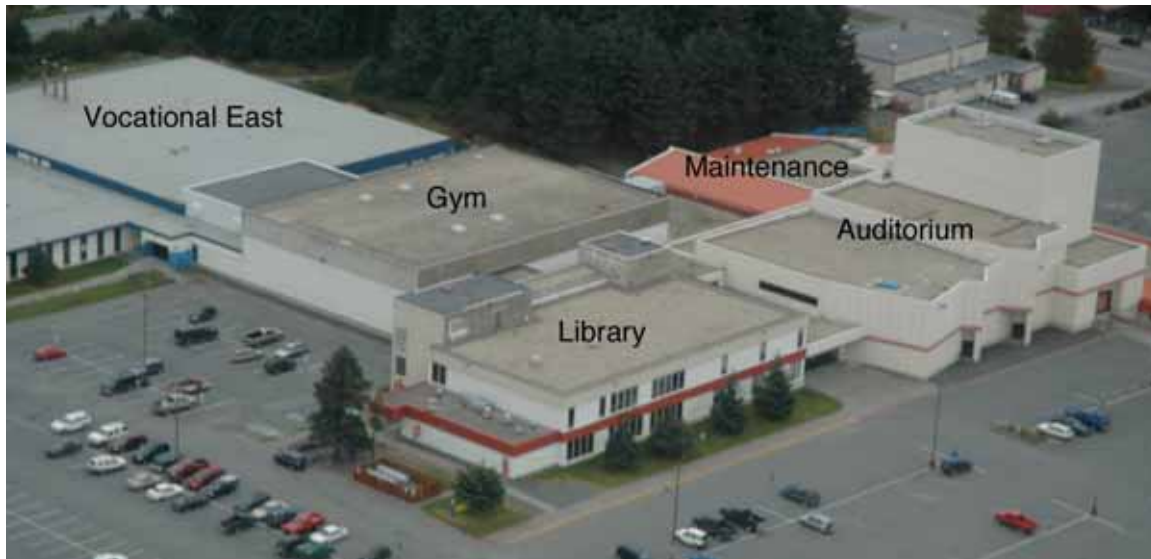
Figure 2-10. Aerial View of High School Complex, Library in Foreground

The library structure is seen in the foreground of Figure 2-10. It is two stories tall, and rectangular in plan, 60 feet (north-south) by 132 feet (east-west). The small one story structure observed in Figure 2-10 to the west of the Library wing is an independent steel moment frame structure, and is seismically adequate.

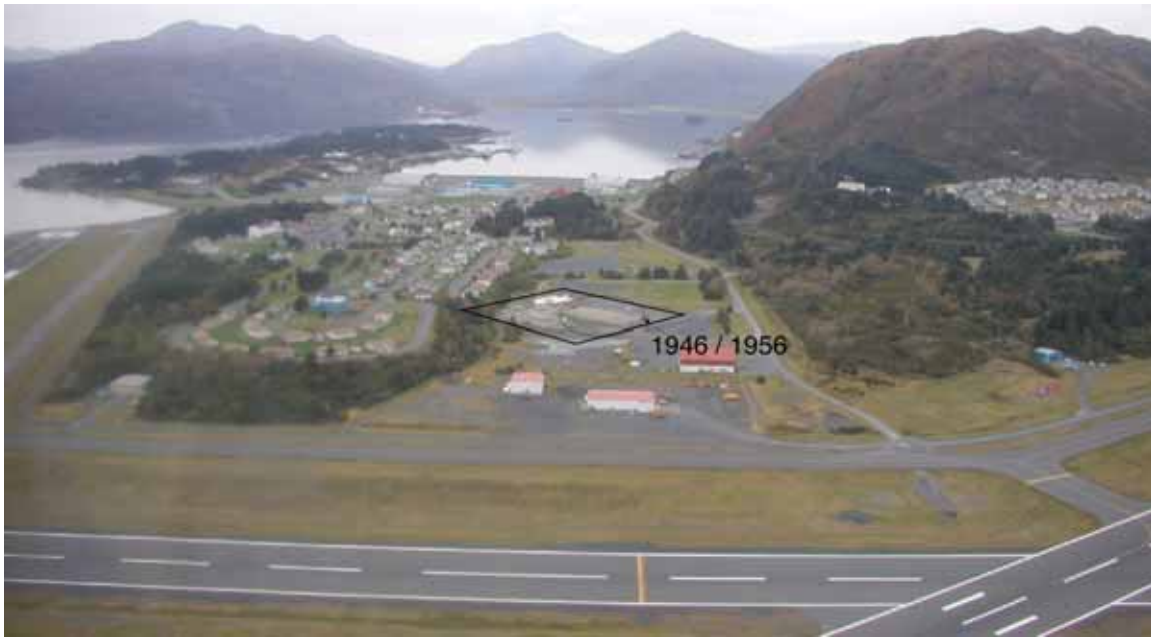
Figure 2-18. Peterson School (behind runways)

As can be seen in Figure 2-18, the school is located in a flat area. Old Womans Mountain is the mountain seen immediately to the right of the school. The soils beneath the school are characterized in WLA (2006), described as dense to very dense gravelly sands, with a soil-to-rock profile suggesting that the school overlies a V-shaped filled-in gully.

The oldest portion of the Peterson school was built circa 1946. This portion is a single story structure, rectangular in plan. A central corridor runs down the long length of the building, with the roof supported on 6x6 wood columns at either side of the central corridor, and by 5I10 steel columns at the two edges of the building. The roof system is composed of 0.5 inch plywood (unknown nailing) atop wood joists supported on glulam beams. In the transverse direction of the building, steel diagonals are used between classrooms to provide some measure of a lateral load path, only designed for wind loads.

In 1956, two classrooms were added to the north end of the school. These two classrooms were constructed with reinforced concrete walls running in the east-west direction and glass block and glass window walls running in the north south direction.

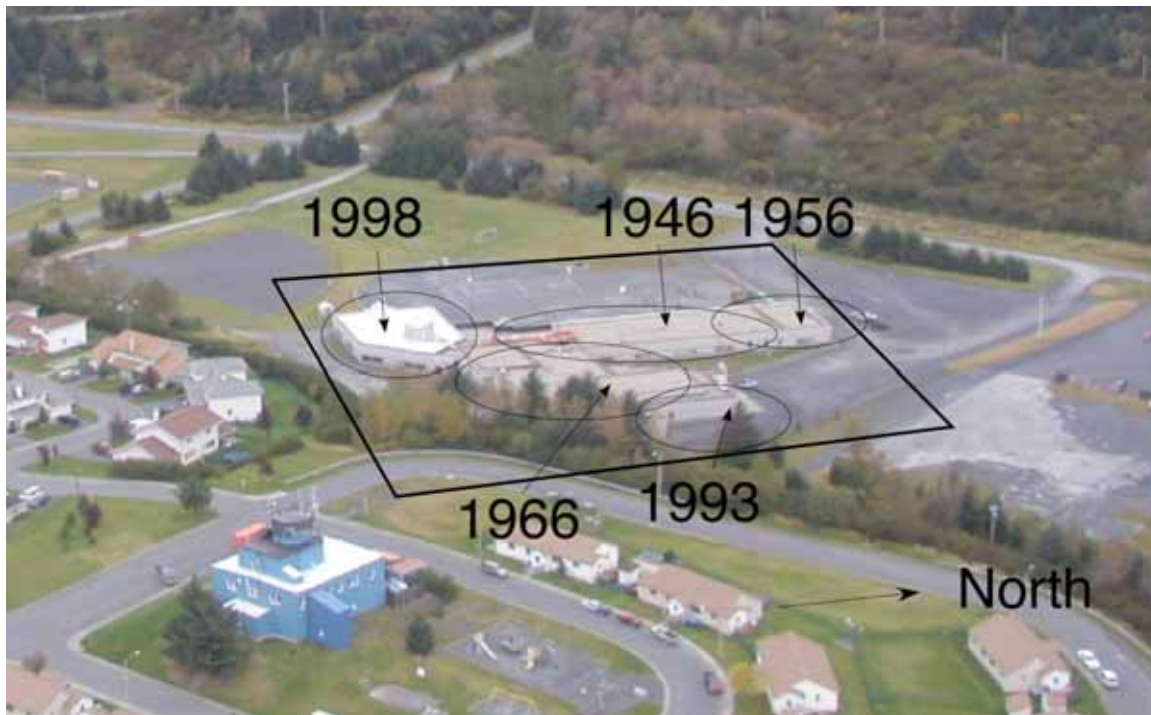
Figure 2-19. Peterson School

In 1966, an addition was made at the southeast end of the building. For this addition, the roof uses a 1.5-inch deep metal deck and is supported on steel joists. Exterior and interior walls are tall (18.3 feet), and are typically 8-inch thick reinforced masonry with one #5 vertical at 32-inches on center and one #5 horizontal at 48-inches on center, plus bond beams at the top. Additional steel was placed around all door and window openings. Masonry units are filled solid where reinforced. This portion of the building was designed per the 1964 UBC per seismic zone 3 requirements.

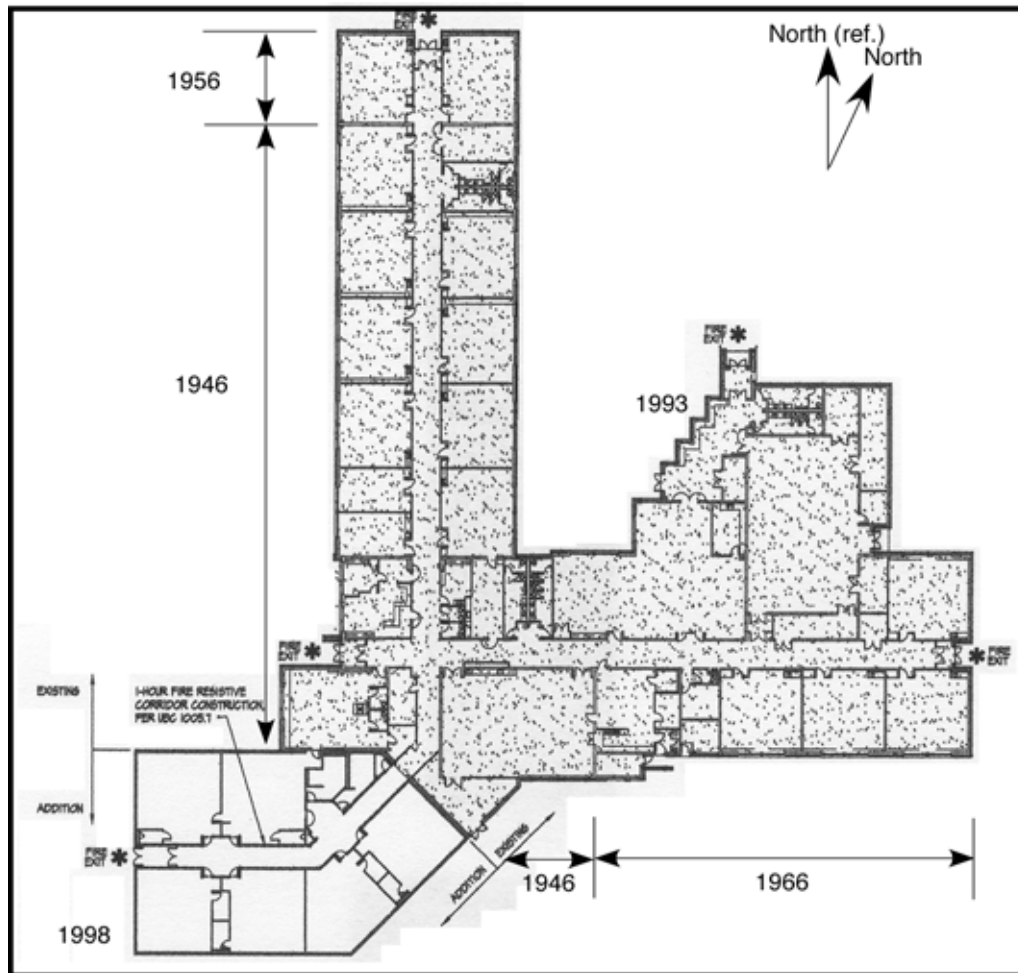
Figure 2-20. Peterson School

return period earthquake would have $PGA = 0.47g$, and design of a new building at this site per IBC would use (about) $PGA = 0.56g$ as the design basis. With these factors in mind, there might be some benefit to upgrade the 1966 portion with the tall masonry walls for an increased level of seismic forces, but this has not been explored.

After consideration for all the additions, of most concern is the seismic capacity of the original 1946 building.

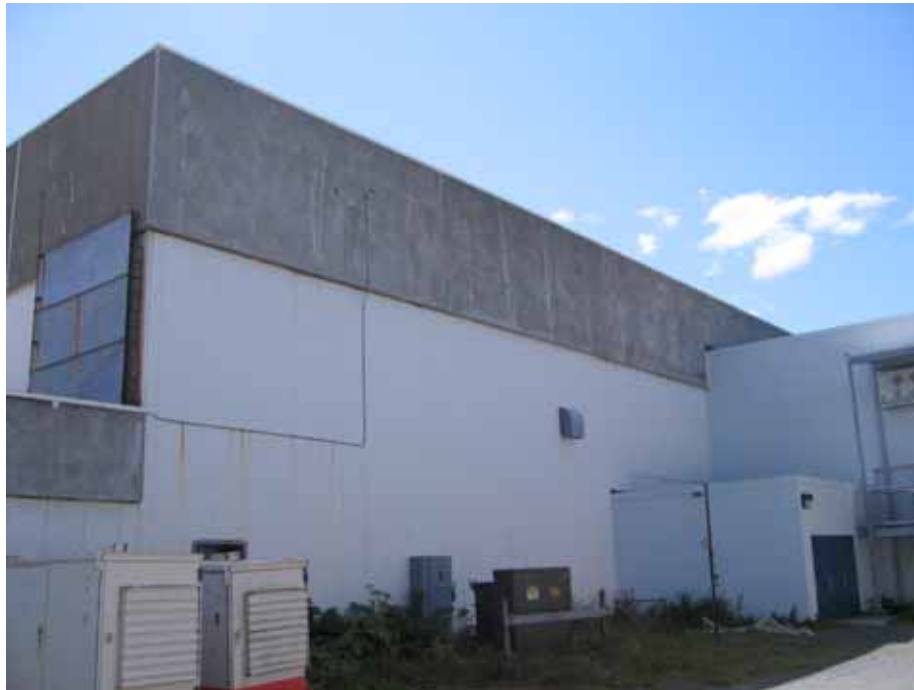
Figure 2-23. Gym, North Façade, Pool (far left), Mat Building (right),

The High School Gym structure is rectangular in plan, 156 feet (east-west) by 120 feet (north-south). The structure is primarily a single story facility, with roof level 34 feet above the finished floor level. Figure 2-10 shows an aerial view of the building as part of the entire High School complex. Figure 2-23 shows the exterior north wall of the Gym, with the lower level swimming pool facility just at the bottom left of the photo.

The roof diaphragm is 1.5 inch deep metal decking. The roof is supported on steel trusses, which in turn are supported on steel columns. Lateral loads are resisted by x- and chevron-braced steel frames located along the exterior walls of the building.

Precast concrete panels are attached to the north-south running trusses at the top level of the building (Figure 2-23). Below the top level precast concrete panels are lightweight metal sheathing panels that extend to the ground level.

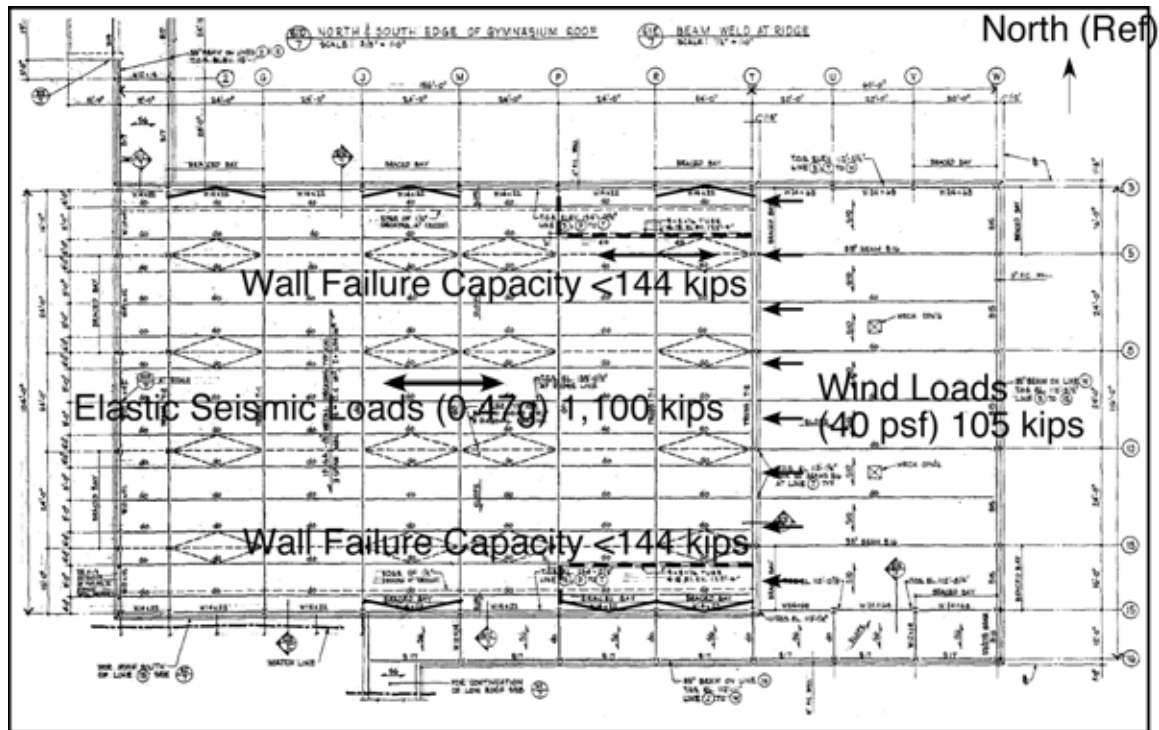
Figure 2-25. Plan of Gym at Roof Level

However, the above findings are somewhat optimistic, given that in fact there are a set of interior non-structural reinforced masonry walls that were installed to form two fan rooms in the Gym. Inspection of these walls within the gym shows that the two walls are already damaged, as can be seen by the telltale diagonal stair-stepped cracks in Figure 2-24. Similar cracks exist in the southeast wall. Figure 2-25 shows the plan of the gym at the roof level, highlighting some of the forces involved.

- Second, we considered whether strong winds might have caused the damage. Immediately outside, the building has a vertical change in elevation of 21.8 feet from the Gym roof to the Pool roof. Assuming an applied wind load of 40 psf, there would be about 105 kips applied to the wall. It is quite possible that the original structural engineer assumed that these wind loads would be distributed through the roof diaphragm to the exterior steel braced frame walls, and ignored that the two walls (heavy dashed lines in Figure 2-25) would take some of this load. Based on the relative location of the masonry walls versus the exterior steel braced frames, the masonry walls would probably take about 90% of the total wind load. The masonry walls are 8-inch with code minimum steel in the horizontal (#5 bar bond beam at 48 inches) and vertical (#4 bar at 32 inches) for a wall of this size. Only the cells with reinforcement were grouted. Thus, the wind load would apply a shear force to these walls which might have been unintended. If one assumes that the available steel in the wall governs, and takes no credit for any masonry strength, the wall could theoretically take about 144 kips, at which point large shear cracks would form in the wall. In practice, owing to limits on the foundation wall attachments and roof attachments, the walls are probably not quite this strong, possibly reaching first yield levels at half this level or so. Even with these considerations, a wind that produced an average pressure of 40 psf on

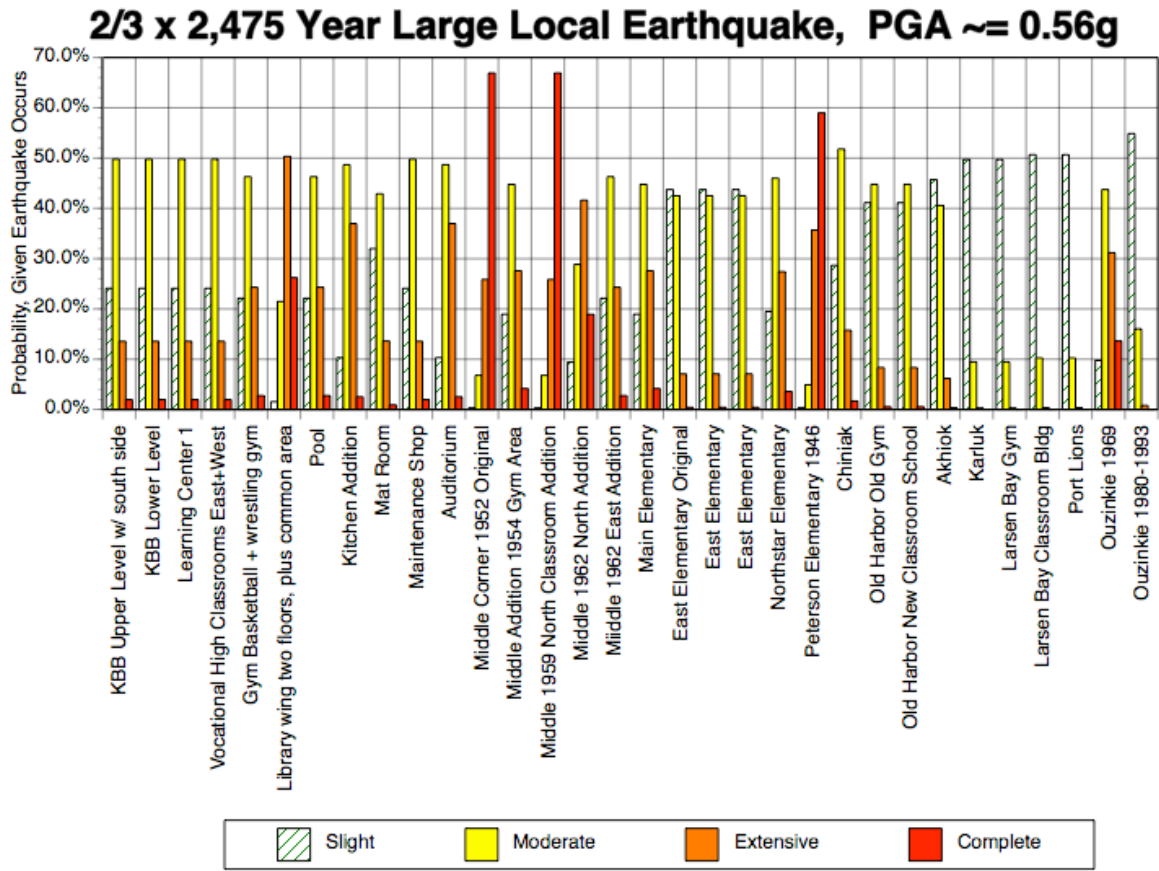
Figure 5-4. Building Performance: 2/3 of 2,475 Year Scenario Earthquake

Sections 5.1 through 5.5 describe what is meant by each damage state for the buildings with the greatest chance of significant damage in large earthquakes. For example, Figure 5-4 shows that the High School Library wing has about a 25% chance of being in the complete damage state, given an earthquake that produces PGA = 0.56g at that site. For that same level of earthquake, the nearby Vocational Wing has a 2% chance of being in the complete damage state.
